# Water Resource Impact Survey

## Kaikoura Earthquake 2016

Flaxbourne Settlers' Association, Marlborough

Date: June 2018  
Reference: 3-53408.00  
Status: FINAL

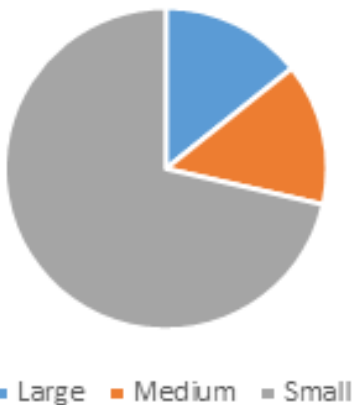
Figure 4.4: Effect of any change in water level on existing operations.

- The impact of any change in water level on 'operations' has so far been small, with only two respondents indicating a greater level of impact. Most respondents expressed concern about the change in river level, and one located near Mirza Creek, noted the change in water level may cause an increased flood hazard. Overall, the risk from the river bed change has been perceived as small; and

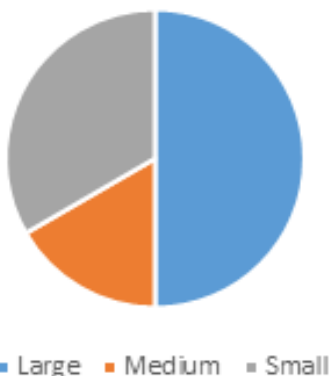
Figure 4.9: Effect of channel changes on farming operations.

- All the changes observed with respect to the characteristics of river and stream channels have so far been permanent i.e. the effects are still apparent. It is also likely that some of the effects have been progressive over time i.e. aggradation or degradation of the bed is continuing;
- Uplift of the mouth of the Flaxbourne River has resulted in the channel deepening by approximately 2m. This has led directly to the draining of the previous estuary and wetland adjacent to Ward Beach; and
- Although only a small number of respondents commented on observed changes to the channel form of the various rivers and streams, these effects have had a significant effect on farming operations (Figure 4.9). Half of the respondents believe that the changes have had a large effect, while the remainder believe that the effects have had a moderate impact on their operations.
