Project Number: 3-53408.00

# Water Resource Impacts of the Kaikōura Earthquake

17 May 2021

*Low-Flow Gauging*

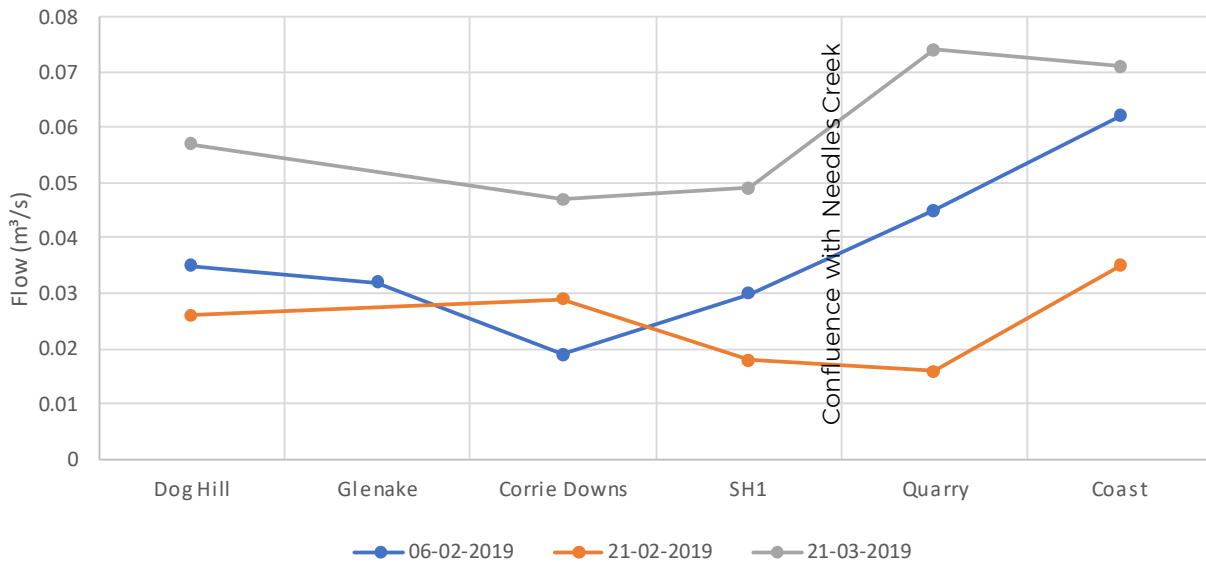
Figure 3-6: Low-flow gauging results from the Flaxbourne River.

Flows recorded in Needles Creek also reduce through the reach between SH1 and Seddon Street, indicating a ‘loss’ of water to the underlying gravel (Figure 3-6).

Subtracting the flows measured at Needles Creek from those measured in the Flaxbourne River downstream of the confluence, does not account for a gain in flow over the lower reach of the Flaxbourne River. It is therefore likely that water is ‘gained’ from the underlying gravel over this reach of river.
